ROOT CAUSE ANALYSIS – 400 THICK STOCK PUMP SHAFT FAILURE

16 August 2009: CONSOLIDATED REPORT BY MST CORPORATION

Subject: Examination of a Fractured Pump Shaft
Lisin Metallurgical Services 402-09-002

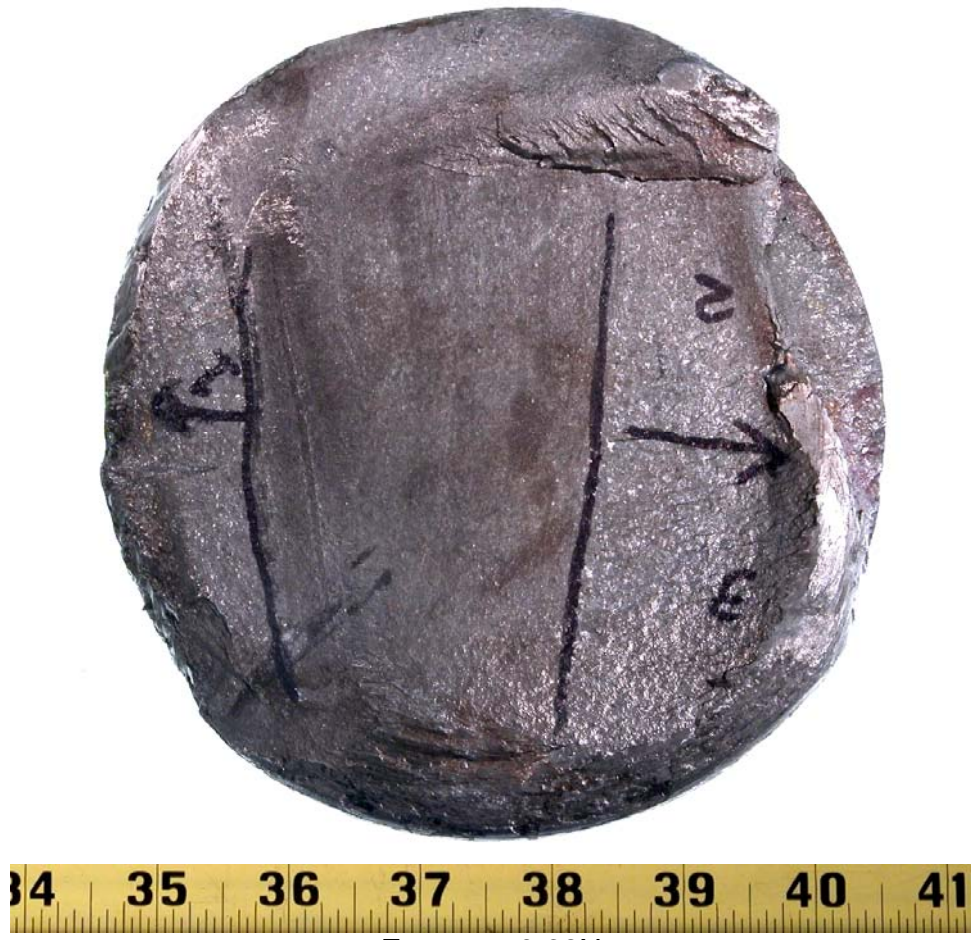
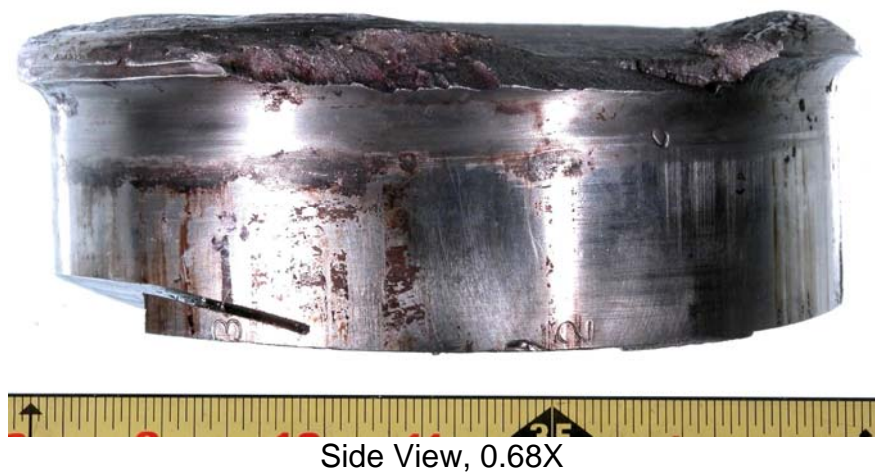
Figure 1

Fracture surface and side view of the fractured shaft. Fracture was predominantly transverse and occurred in the fillet radius. The faint parallel lines of the fracture appear characteristic of crack arrest marks. The transverse fracture orientation, faint crack arrest marks, and absence of significant deformation are consistent with bending fatigue.

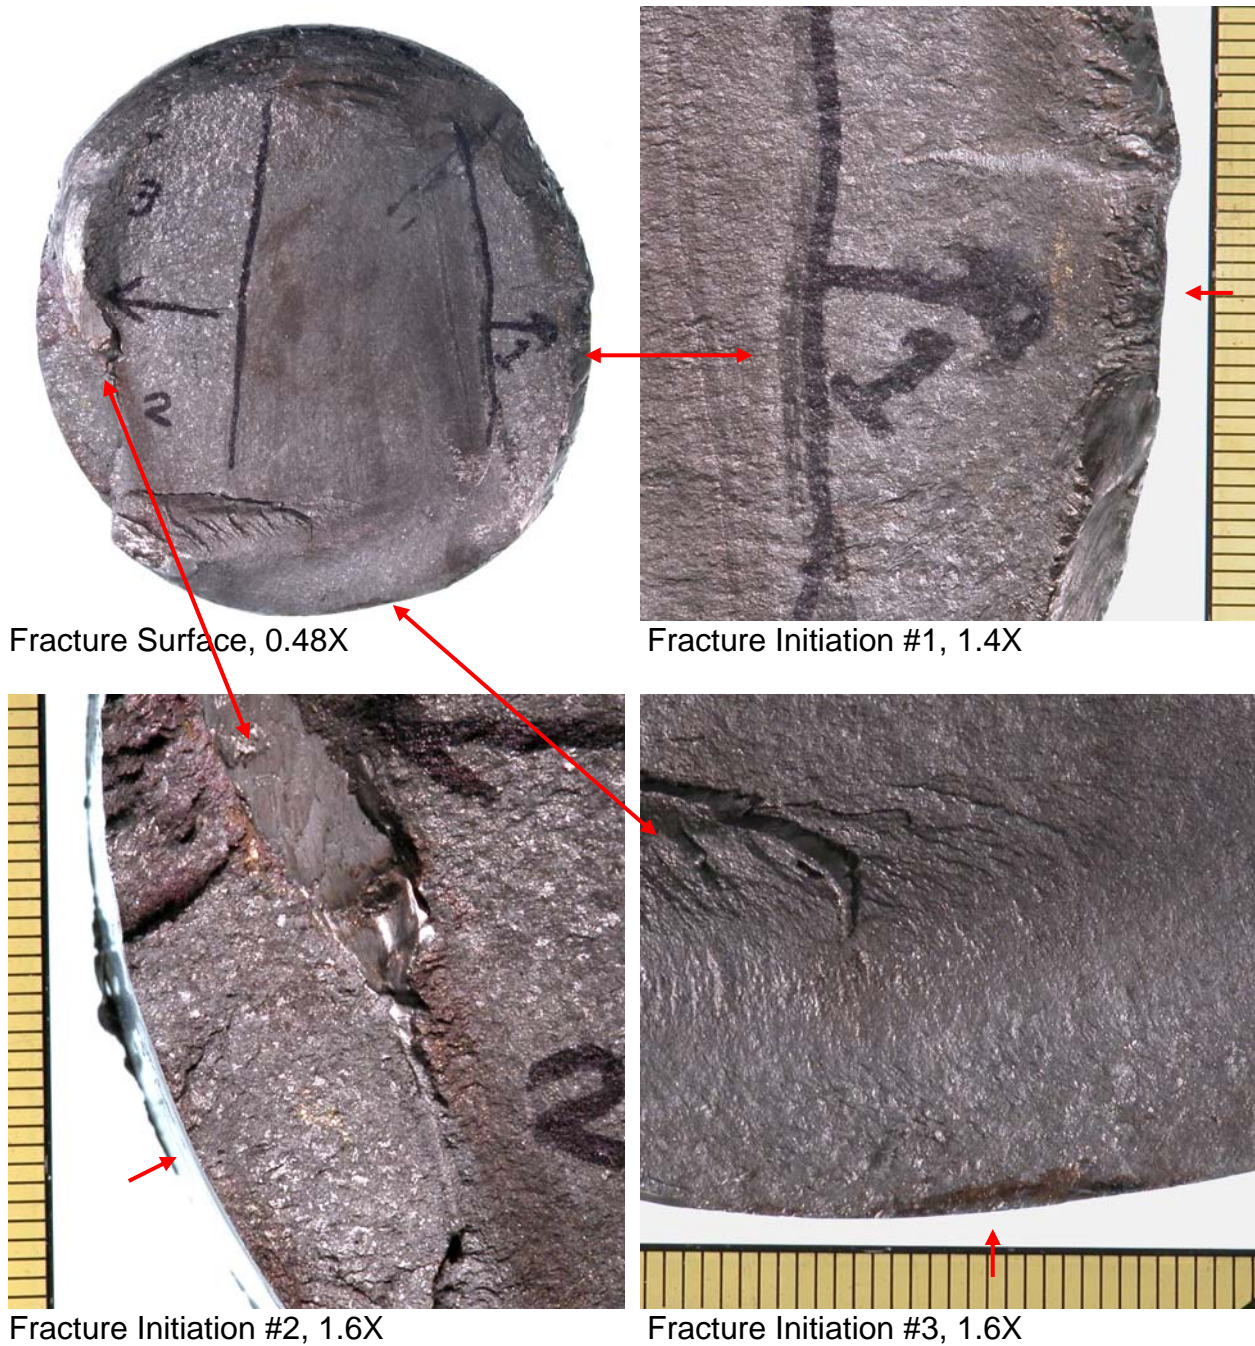
Figure 2

Higher magnification views of apparent fracture initiation sites. The locations of fracture initiation are indicated by faint ridges radiating from locations on the cylindrical surface. The crack arrest marks shown in the upper right photograph are consistent with fatigue crack propagation. The multiple fracture initiation sites spaced around the circumference are consistent with rotating bending fatigue. The large area of fatigue fracture relative to the area of ductile overload fracture is consistent with a high cycle, low stress fatigue fracture.

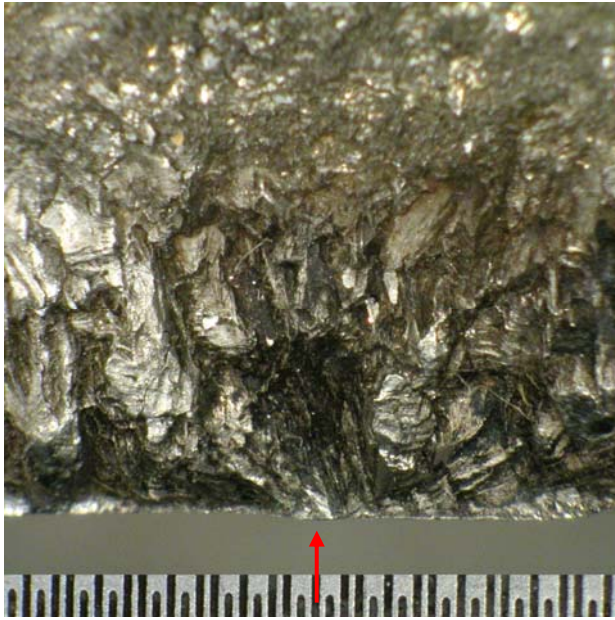
Fracture Initiation #1, 7.6X

Higher magnification views of apparent fracture initiation sites. The designations #1, #2, and #3 are arbitrary and do not indicate a sequence of fracture. Fracture initiation sites #1 and #2 appear to have initiated at the point of tangency between the radius and the cylindrical surface of the shaft. Fracture initiation site #3 appears to have initiated within the radius.

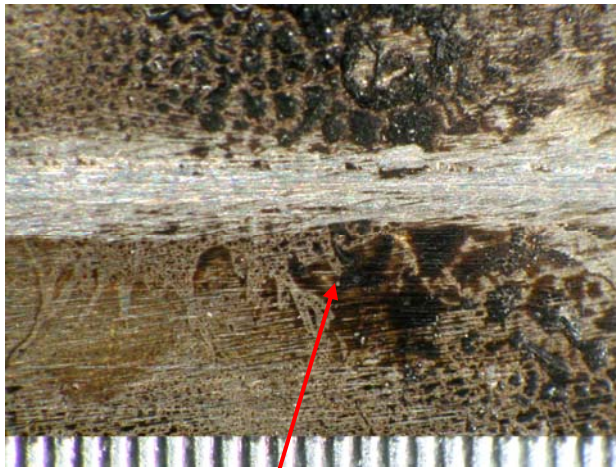
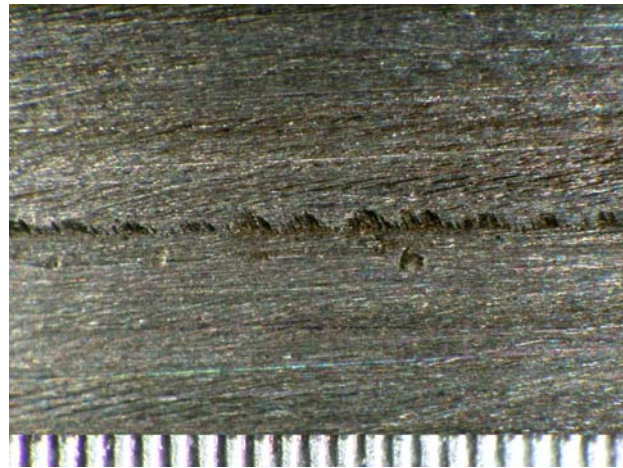
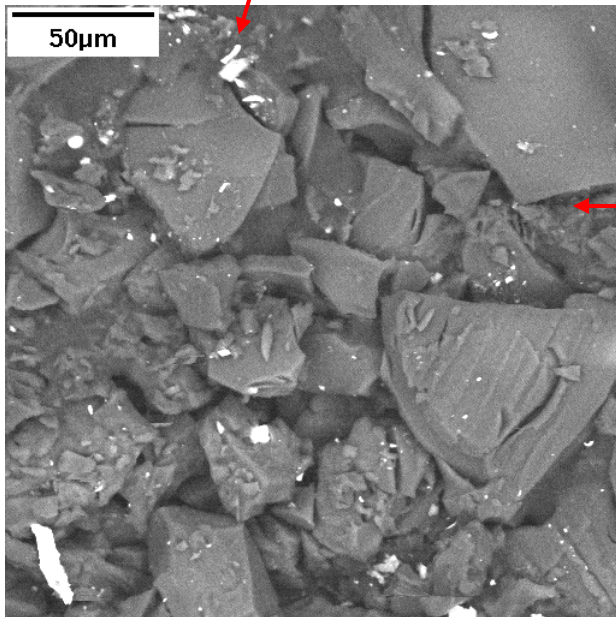
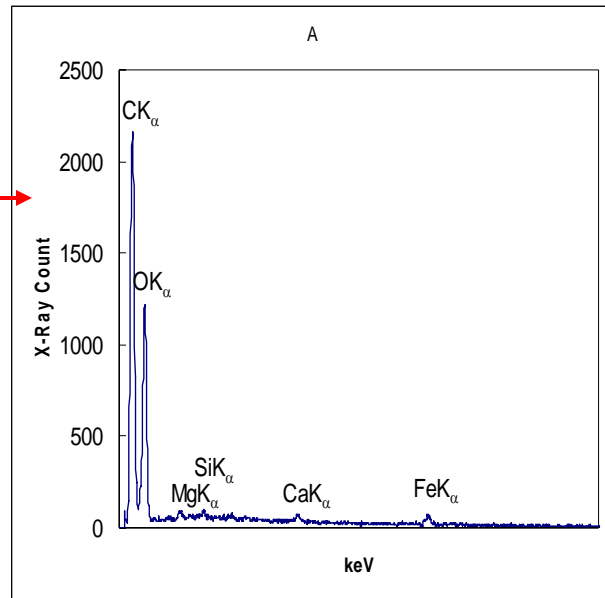
Figure 4

Optical microscope inspection of the filler radius adjacent to the fracture initiation sites revealed a loosely adherent brown deposit. Removal of the deposit by wire brushing revealed fine circumferential scoring characteristic of a ground surface. A single circumferential score mark may be the remnants of an as-machined surface that was not cleaned up by grinding. The feature would predictably act as a stress concentration and promote fatigue fracture. The feature did not appear to be the result of corrosion or localized wear. Pitting corrosion or additional cracking was not revealed by low magnification inspection of the cleaned radius.

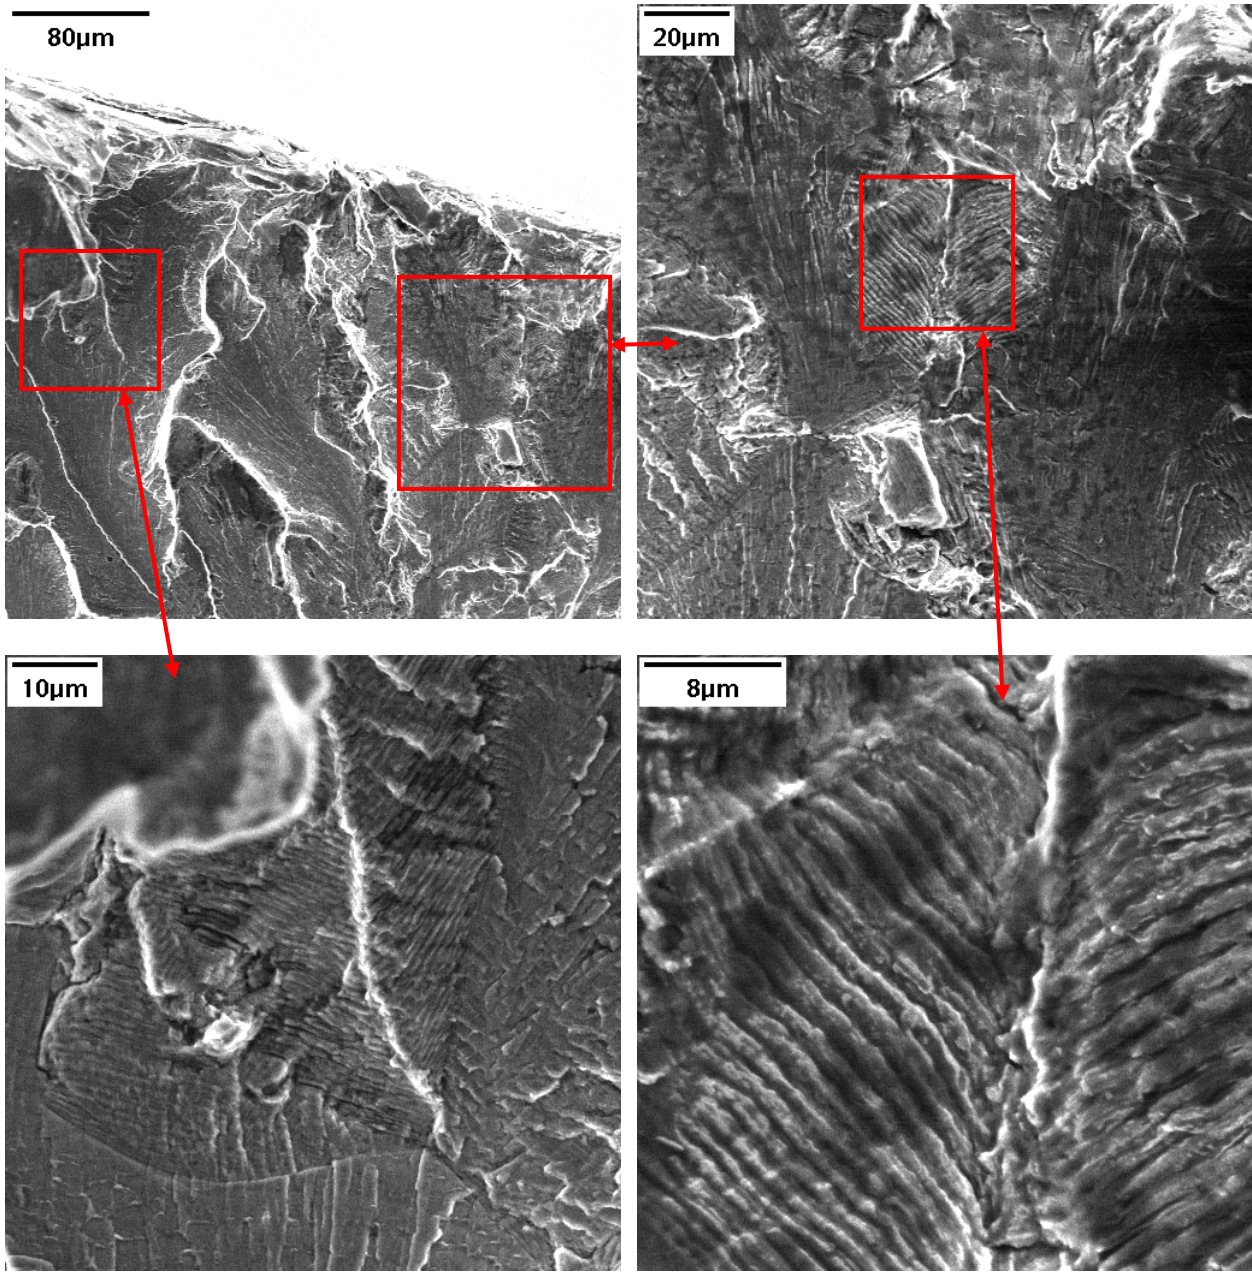
Figure 5
Backscattered electron images acquired from fracture initiation #2.

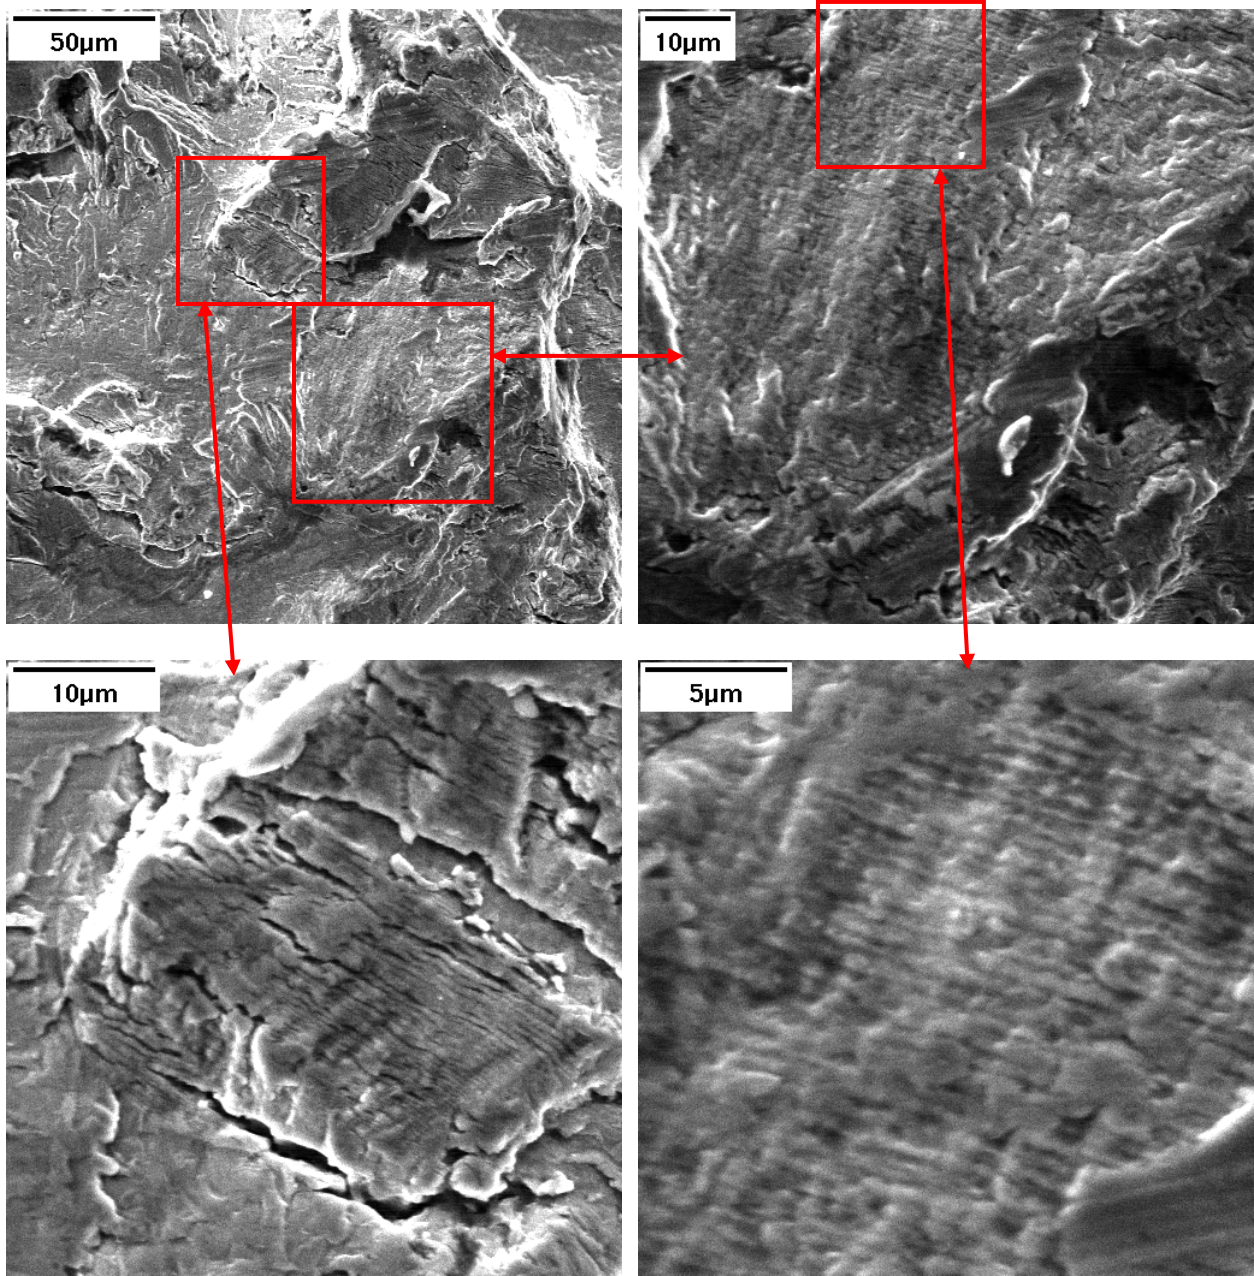
Figure 6
Backscattered electron images acquired from fracture propagation.

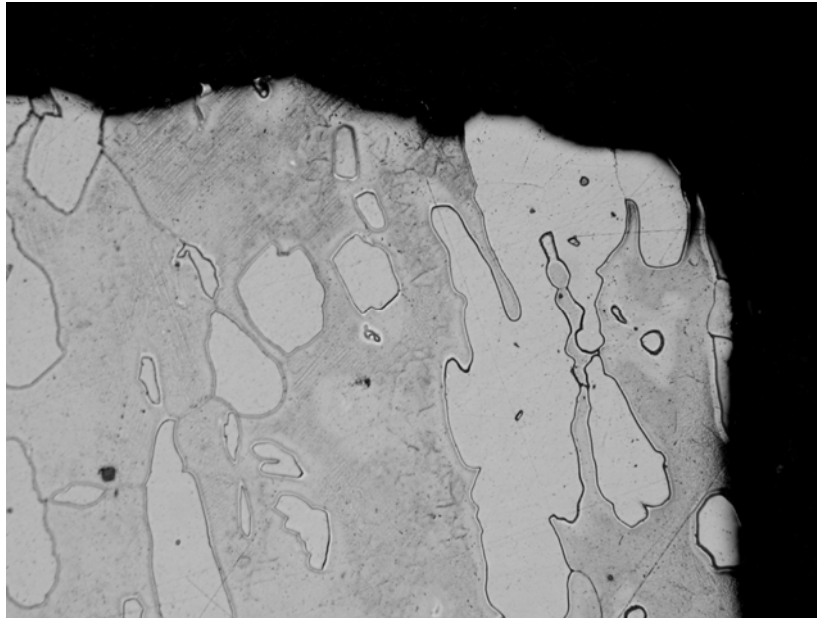
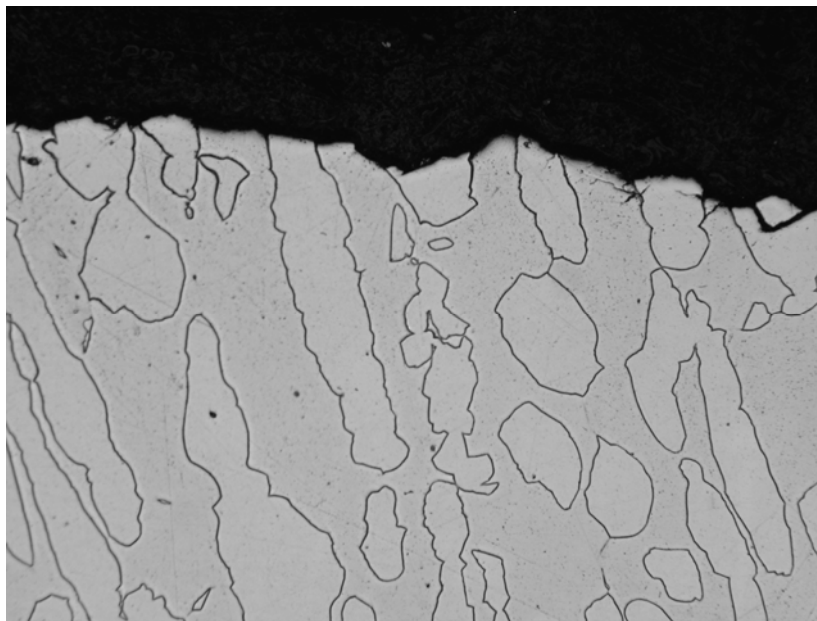
Figure 7

Representative microstructures revealed by radial-longitudinal metallographic sections through fracture initiation site #1 and an area of fracture propagation. The microstructure consists of a roughly equal mix of austenite islands in a ferrite matrix. Precipitation of carbides or intermetallic phases is not apparent. Cracking followed a straight, unbranched, transgranular crack path. The crack path is consistent with fatigue crack initiation and propagation. An absence of pitting or intergranular fracture indicates that fracture was not the result of corrosion. 40% NaOH Electrolytic, ASTM A 923 Practice A,

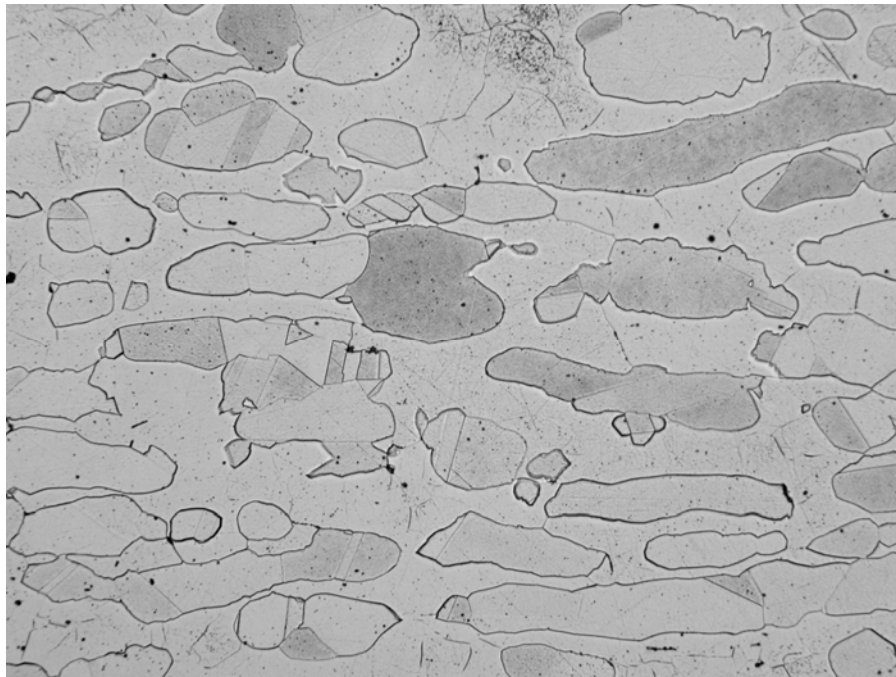
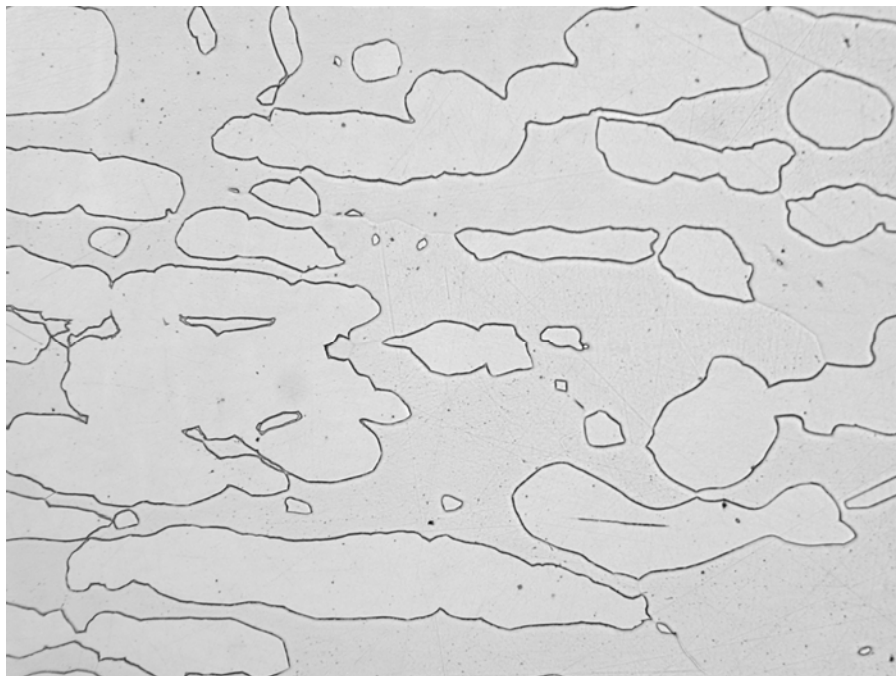
Figure 8

Representative microstructures of the fractured pump shaft at a near surface location. The microstructure consists of austenite islands in a ferrite matrix. The ratio of austenite to ferrite is roughly 1:1. No precipitation of carbides or detrimental intermetallic phases is apparent. The microstructure is consistent with a properly solution annealed 2205 duplex stainless steel alloy.
